Coal Combustion Waste Impoundment Round 5 - Dam Assessment Report

Plant Wansley (Site # 006)
Ash Pond Separation Dike

Georgia Power
Carrolton, Georgia

Dewberry & Davis, LLC
Fairfax, Virginia

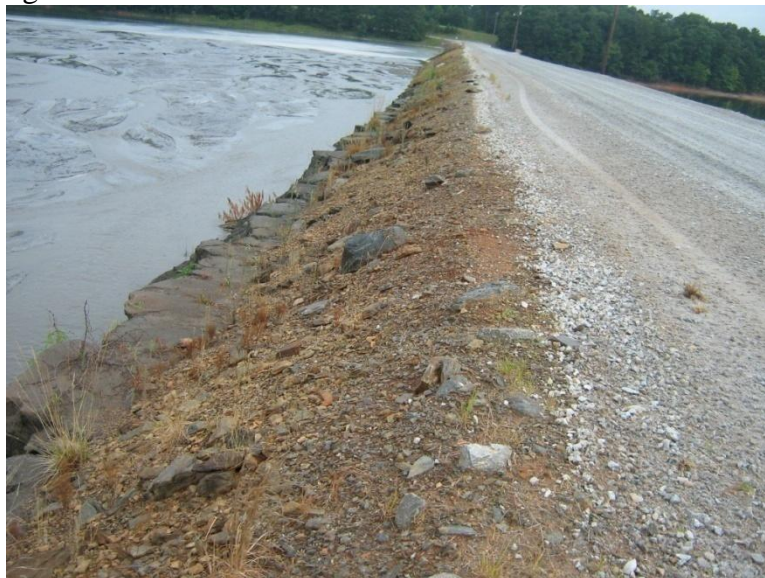
Figure 5.2.2a: Crest and Upstream Slope of ash pond's separation dike.

The upstream slope of the separation dike is mostly lined with rip rap and stone. Scarps, sloughs, depressions, bulging or other indications of slope instability or signs of erosion were not observed.

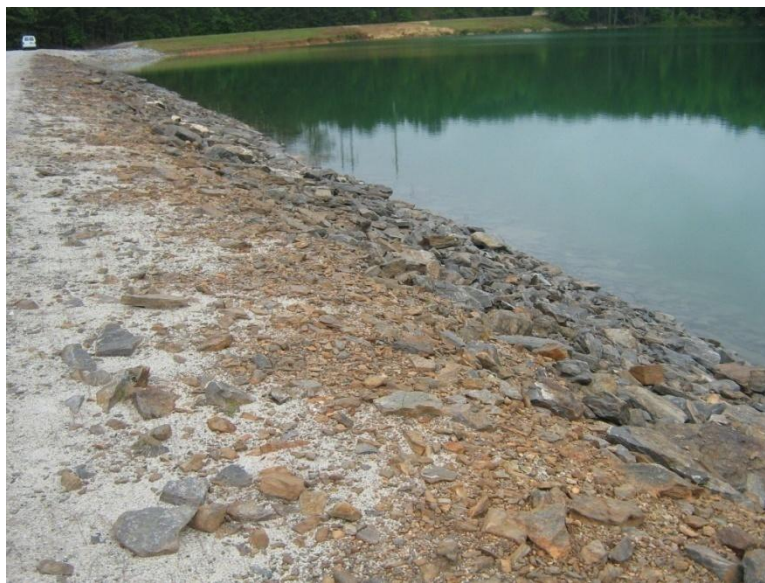
Figure 5.2.2b: Upstream side of western dike

The upstream slope of the western dike is mostly lined with rip rap and stone. Scarps, sloughs, depressions, bulging or other indications of slope instability or signs of erosion were not observed.

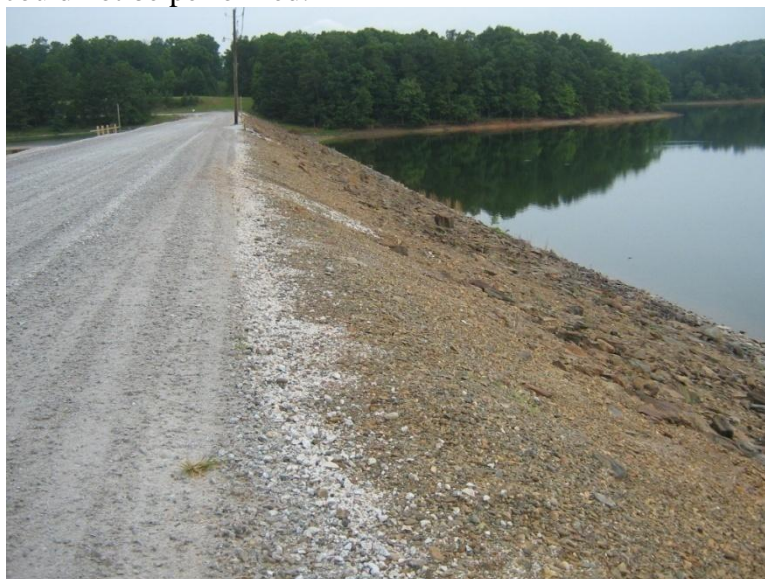
Figure 5.2.3a: Crest and Downstream Slope of ash pond's separation dike.

The downstream slope is mostly lined with rip rap and stone. Scarps, sloughs, depressions, bulging or other indications of slope instability or signs of erosion were not observed. Gravel had been placed at a few locations along the embankment as some regular maintenance. The toe of this slope is below the normal pool of the cooling water pond; therefore, visual assessment of seepage could not be performed.

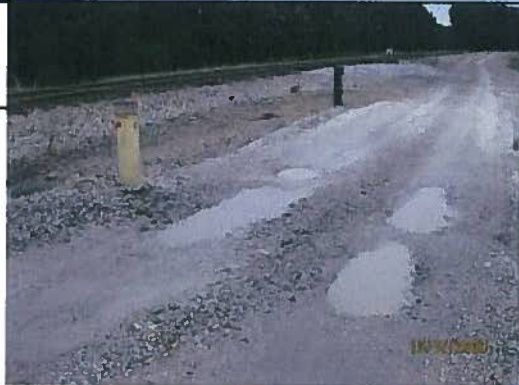
| Photo No. | Description | |
|---|---|--|
| 1 | Storage Pond - East Dike - Crest - Localized depressions at crest should be filled with Graded Aggregate Base (GAB). | |

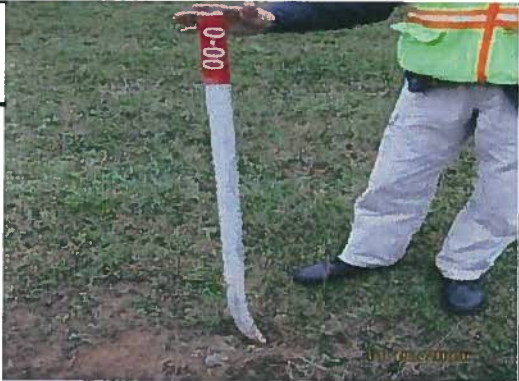
| Photo No. | Description | |
|---|---|--|
| 2 | Storage Pond - East Dike - Marker pole at Sta 0-00 needs to be re-installed. Has been broken off at ground level | |

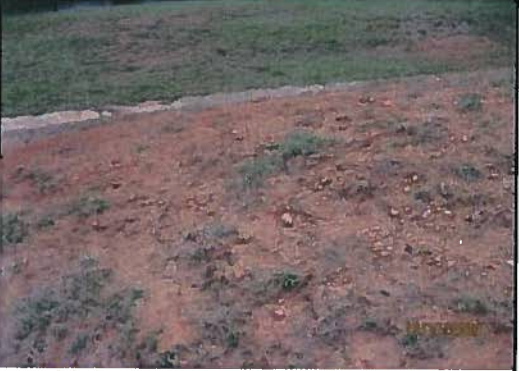
| Photo No. | Description | |
|---|---|--|
| 4 | Storage Pond - East Dike - Bare areas need to be re-grassed. (Use of a grass mat type product will minimize erosion/wash out during initial growth of grass) | |

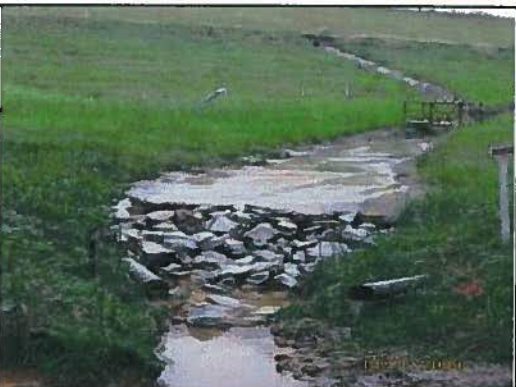
| Photo No. | Description | |
|---|---|--|
| 10 | Storage Pond - Southeast Dike - Lower Slope - Sta 37+00 - Undermined area at end of concrete lined ditch fixed satisfactorily. | |

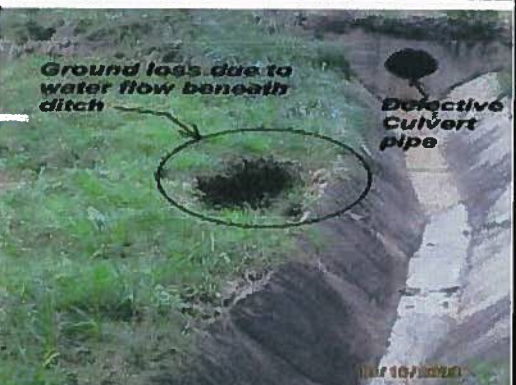
| Photo No. | Description | |
|---|---|--|
| 11 | Storage Pond - Southeast Dike-Downstream-Lower Slope -Sta 37+50 - Ground loss resulting from defective/leaking (corroded) culvert allowing water to flow beneath and beside concrete ditch. Both items have been repaired since inspection on 10-16-09. | |

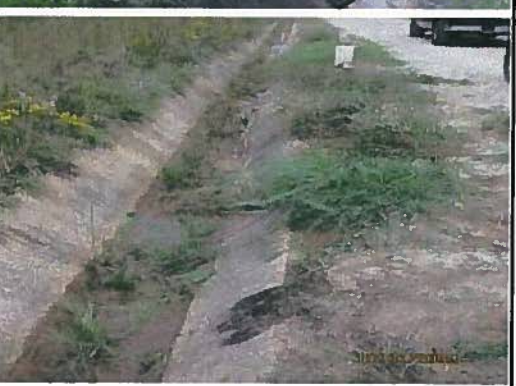
| Photo No. | Description | |
|---|---|--|
| 12 | Storage Pond- Southeast Dike - Mid-slope Ditch - Mud and vegetation needs to be removed from ditches. | |

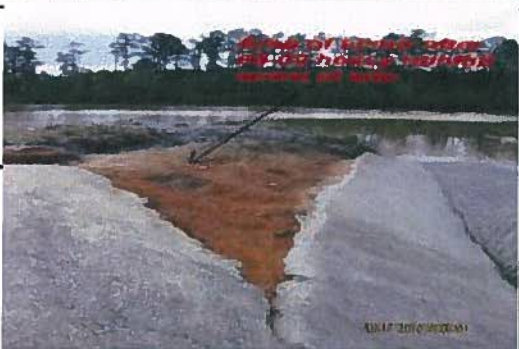
| Photo No. | Description | |
|---|---|--|
| 14 | Ash Pond- Emergency Overflow - Downstream - Scour adjacent to concrete channel which occurred during Sept-09 heavy rainfall at site. Requires repair. | |

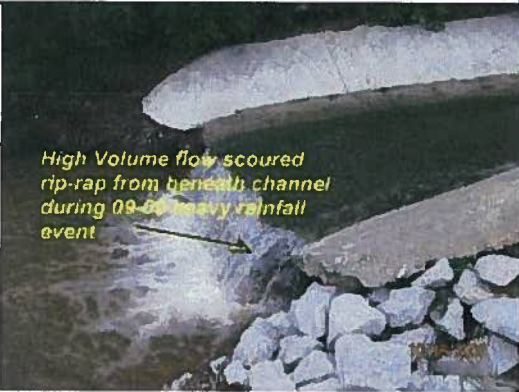
| Photo No. | Description | |
|---|---|--|
| 15 | Ash Pond- Emergency Overflow - End of Concrete Channel - Rip-rap has been scoured from beneath end of concrete channel following 09-09 heavy rainfall at site. | |

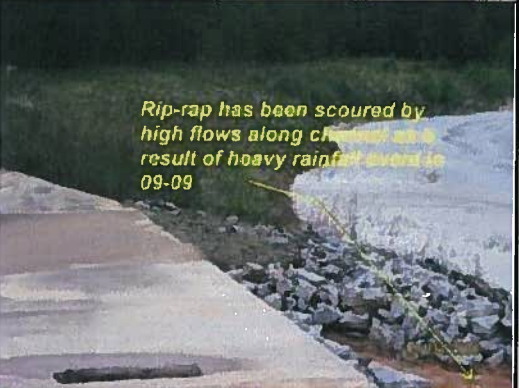
| Photo No. | Description | |
|---|---|--|
| 16 | Ash Pond- Emergency Overflow - Spillway - Rip-rap was scoured due to high flows in adjacent concrete channel following 09-09 rain event | |

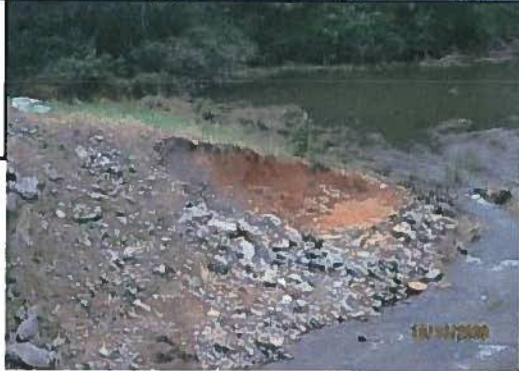
| Photo No. | Description | |
|---|--|---|
| 17 | Potable Water Pond- Spillway - Upstream - Left, upstream spillway approach embankment needs to be repaired. Hydro Services has provided plant personnel with repair procedure. | |

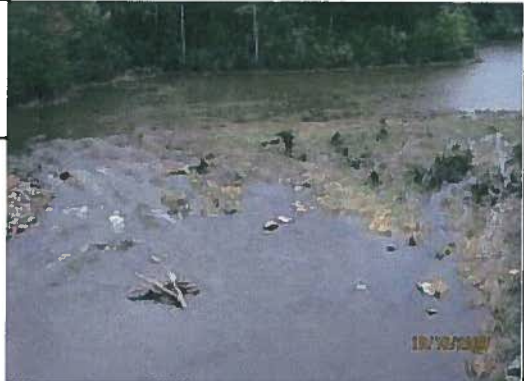
| Photo No. | Description | |
|---|--|---|
| 18 | Potable Water Pond - Spillway (Upstream) - Rip-rap was scoured due to high flows in adjacent concrete channel following Sept-09 rain event. | |

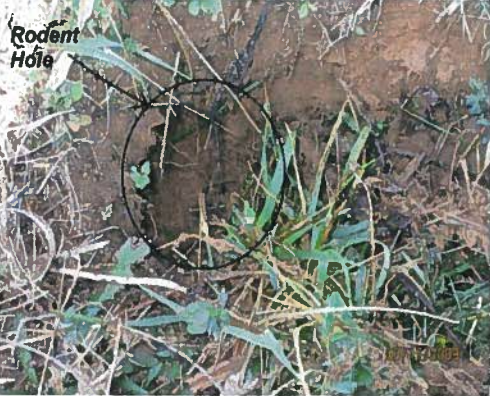
| Photo No. | Description | |
|---|--|--|
| 3 | Storage Pond - East Dike - Localized rodent holes observed on slope need to be filled in. | <p>Rodent Hole</p> |

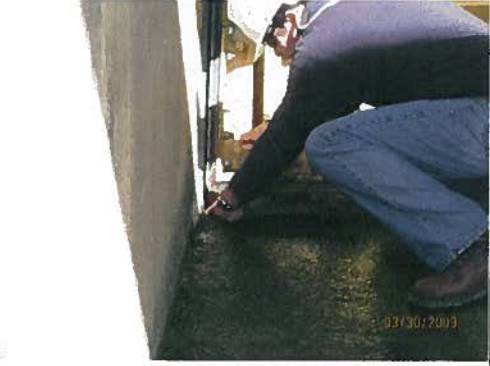
| Photo No. | Description | |
|---|--|--|
| 4 | Storage Pond - Spillway Gates - Slight gap between wall and edge of gate allowing water through. Plant to investigate. | |

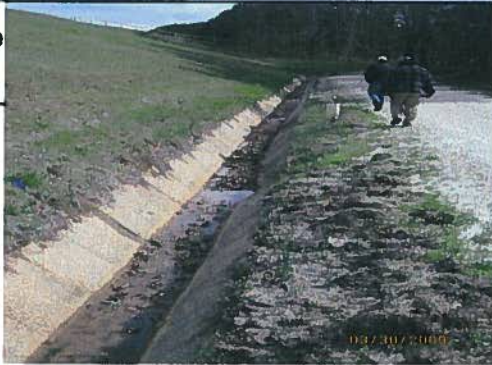
| Photo No. | Description | |
|---|---|--|
| 5 | Storage Pond - East Dike -Toe Ditch - Mid-slope - Bare spots on slope need to be re-graseed. | |

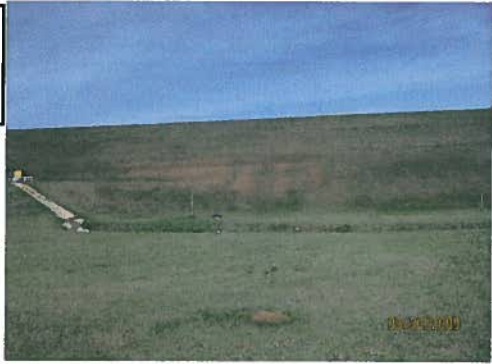
| Photo No. | Description | |
|---|---|--|
| 6 | Storage Pond - East Dike -Lower Slope - Bare spots on slope need to be re-graseed. | |

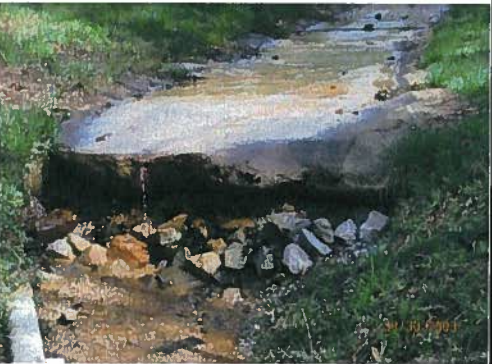
| Photo No. | Description | |
|---|---|--|
| 8 | Storage Pond - East Dike -Lower Slope - Sta 37+00 - Repair undermining at end of concrete lined ditch | |

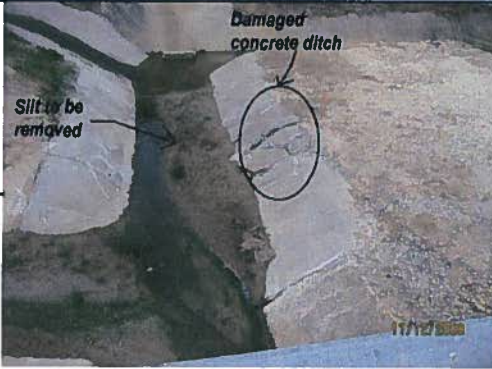
| Photo No. | Description | |
|---|---|--|
| 9 | Storage Pond - Southeast Dike - Downstream-Lower Slope -Sta 62+00 - Damaged concrete needs repair and removal of silt removal at bottom of ditch. | |

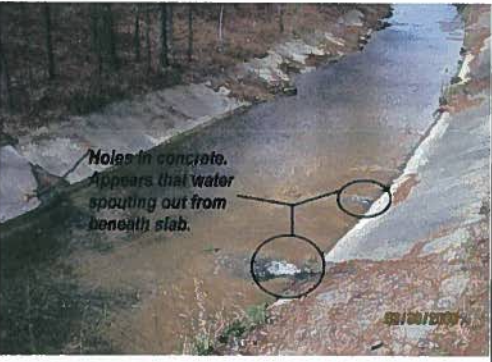
| Photo No. | Description | |
|---|---|--|
| 11 | Ash Pond- Emergency Overflow - Bottom of Concrete Ditch - Several holes in concrete and water spouting from hole. Needs to be investigated and repaired. | |

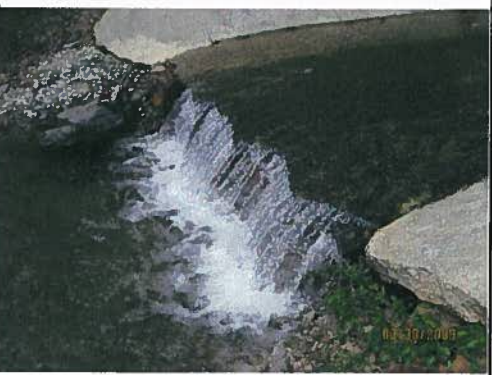
| Photo No. | Description | |
|---|---|--|
| 12 | Ash Pond- Emergency Overflow - Downstream End - Erosion at end of ditch resulting in undermining of concrete. Needs to be repaired. | |

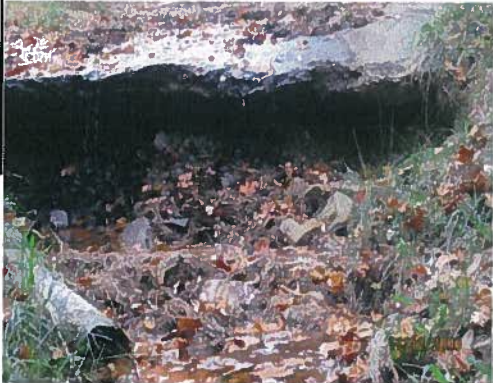
| Photo No. | Description | |
|---|--|--|
| 15 | Storage Pond - Southeast Dike - Downstream-Lower Slope at Sta 37+ 50 - Undermining at end of concrete drainage ditch requires repair. (See repair procedure in letter of May 28, 2008) | |

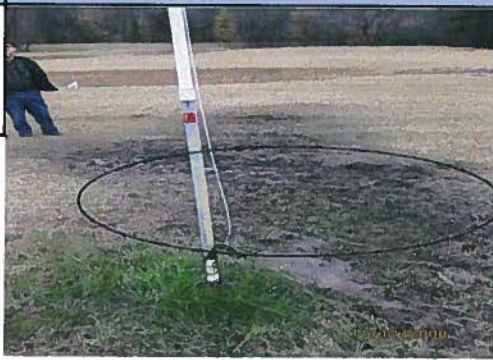
| Photo No. | Description | |
|---|--|--|
| 17 | Storage Pond - Southeast Dike - Downstream - Lower Slope - Wet area around Piezometer LLL. Appears that drain valve is leaking. Needs to be repaired. | |

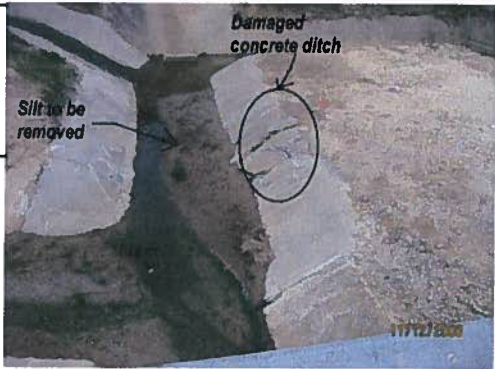
| Photo No. | Description | |
|---|--|--|
| 18 | Storage Pond - Southeast Dike - Downstream- Lower Slope -Sta 62+00 - Damaged concrete needs repair and removal of silt removal at bottom of ditch. | |

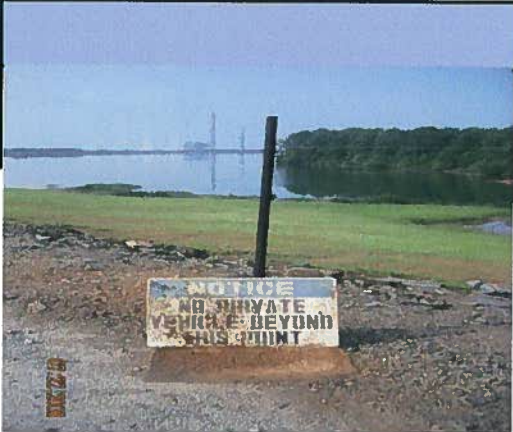
| Photo No. | Description | |
|---|---|--|
| 1 | Storage Pond - N Dike - Near Rec. Center Entrance - Warning sign needs to be re-mounted. | |

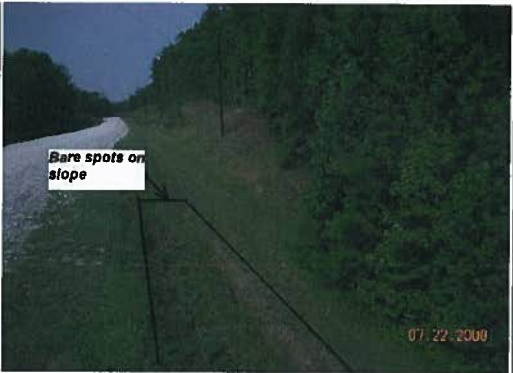
| Photo No. | Description | |
|---|---|--|
| 2 | Storage Pond - N. Dike - Localized bare spots in grass cover. Re-establish grass to prevent erosion. | |

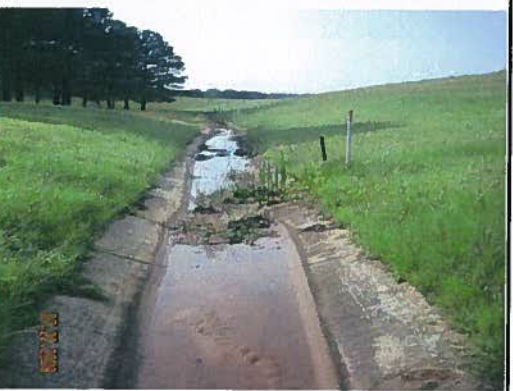
| Photo No. | Description | |
|---|---|--|
| 4 | Storage Pond - E. Dike - D/S slope - Toe Ditch - Localized vegetation and debris needs removal so that flow isn't restricted. (Sta.1+60 to 3+50). | |

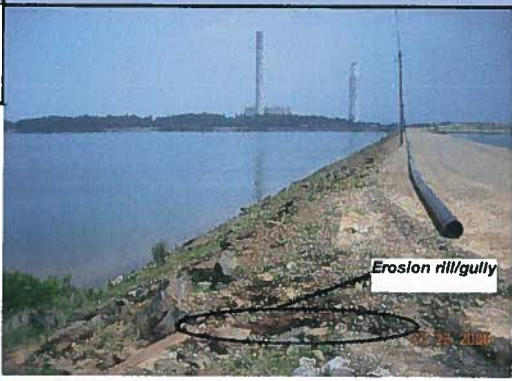
| Photo No. | Description | |
|--|---|--|
| 17 | Storage/Ash Pond - Separator Dike - Upstream Slope. No evidence of instability or distress. Minor erosion rills/gullies need to be filled in. | |

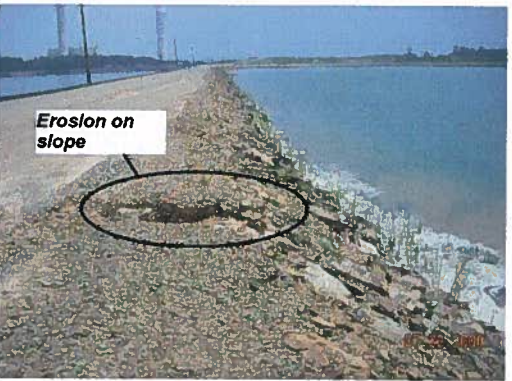
| Photo No. | Description | |
|--|---|--|
| 18 | Storage/Ash Pond - Separator Dike - Downstream Slope - Localized erosion rills/gullies need to be repaired to prevent further erosion. | |

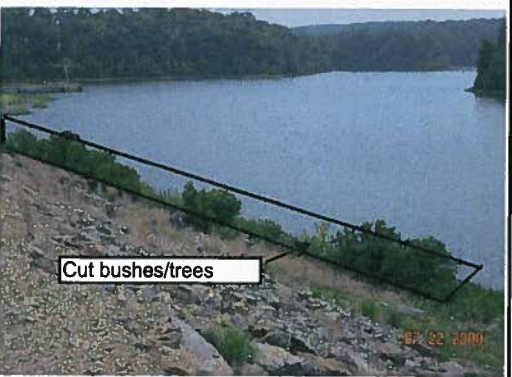
| Photo No. | Description | |
|--|---|--|
| 20 | Potable Water Pond- Upstream Slope. Small trees/bushes at toe need to be removed. | |

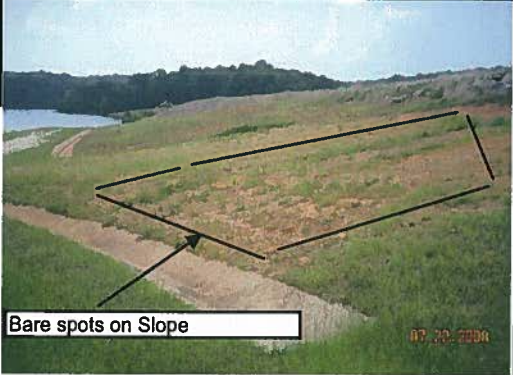
| Photo No. | Description | |
|---|---|--|
| 21 | Potable Water Pond- Upstream Slope. Localized bare spots on slope. Re-establish vegetation to prevent further erosion | |

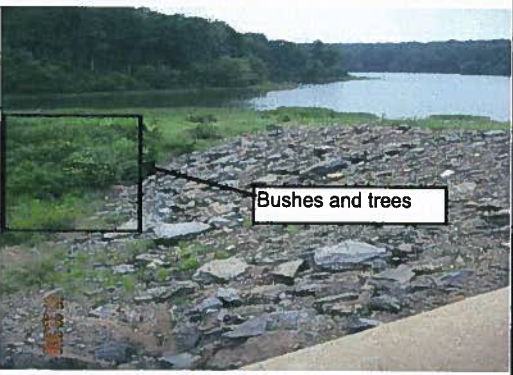
| Photo No. | Description | |
|---|---|--|
| 22 | Potable Water Pond-Spillway Approach Channel- Remove small trees/bushes within channel. | |

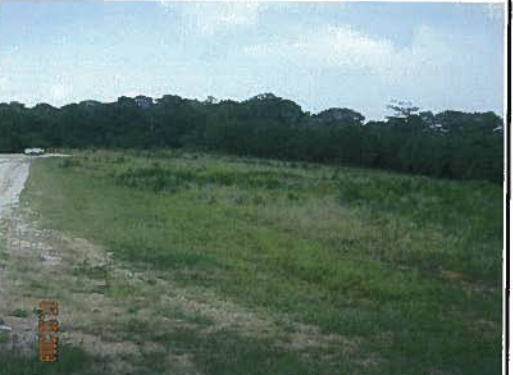
| Photo No. | Description | |
|---|---|--|
| 24 | Detention Pond - Downstream Slope - Good grass cover, but needs to be cut. Small trees/bushes on slope need to be cut down. | |

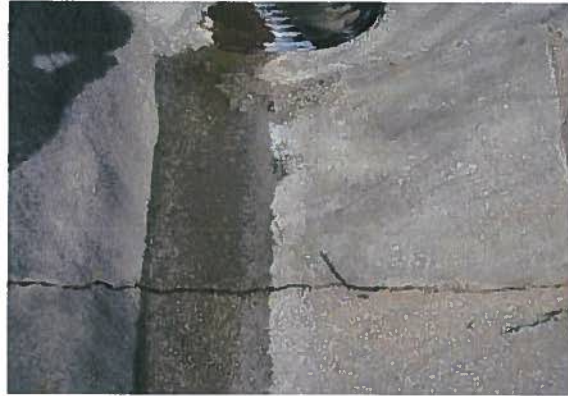
Pt. 130 – Cracks in concrete lined channel. **Cracks like this should be cleaned out of dirt and caulked (using a appropriate caulking material).** This will prevent water infiltration and progressive undermining beneath the concrete,

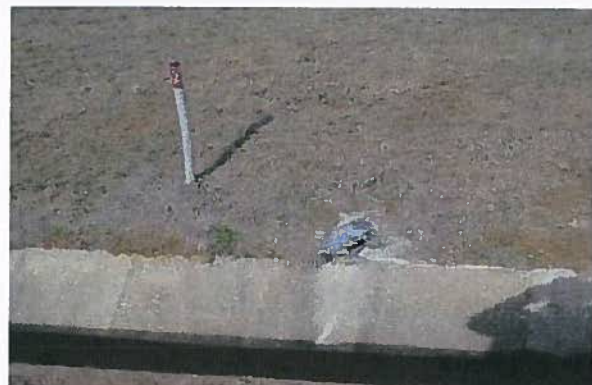
Sta. 72+50 and 70+00 (pictured) and 66+00
– End of toe and finger drains damaged by mowers. **Repair ends of drains (i.e. add new section of pipe or beat back into shape). Provide markers to prevent re-occurrence**

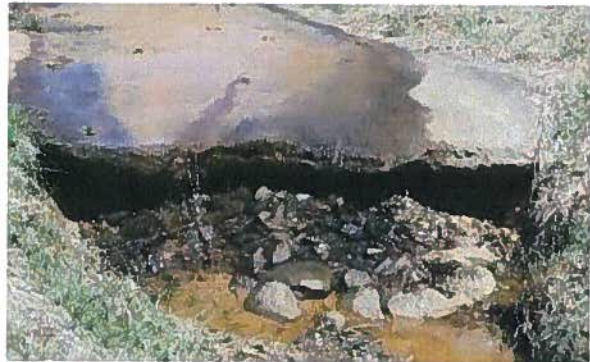
Sta. 37+50 – Progressive undermining of concrete paving. **Requires repair to mitigate further ground loss and future damage to pavement. (See attached Sketch No. 1 below for proposed repair option)**

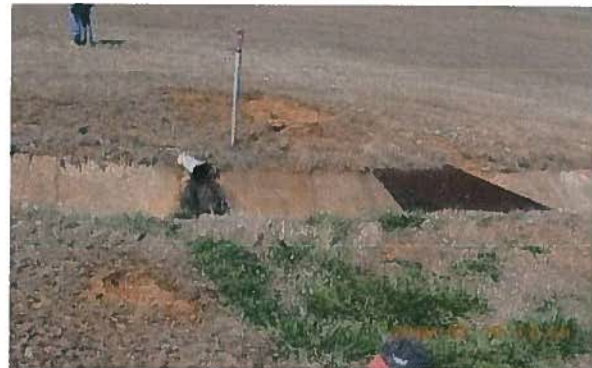
Pt 152 (Sta. 68+00) –Bare spots in slope
Localized re-seeding to re-establish grass cover.

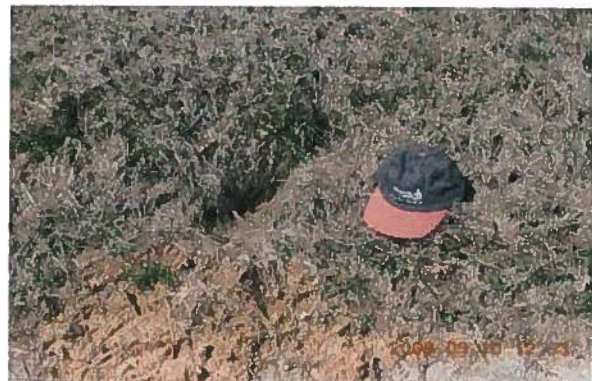
Pt 153 – Animal burrow just upslope from concrete drainage channel (approx Sta. 68+00). **Requires repair/filled in.**

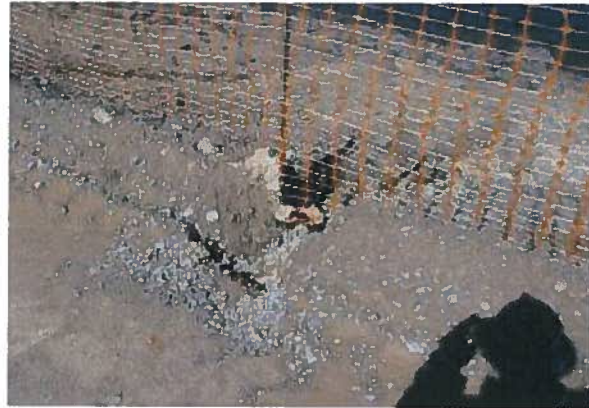
Crest of Upstream Slope - Localized erosion rill needs to be repaired with #57 stone.

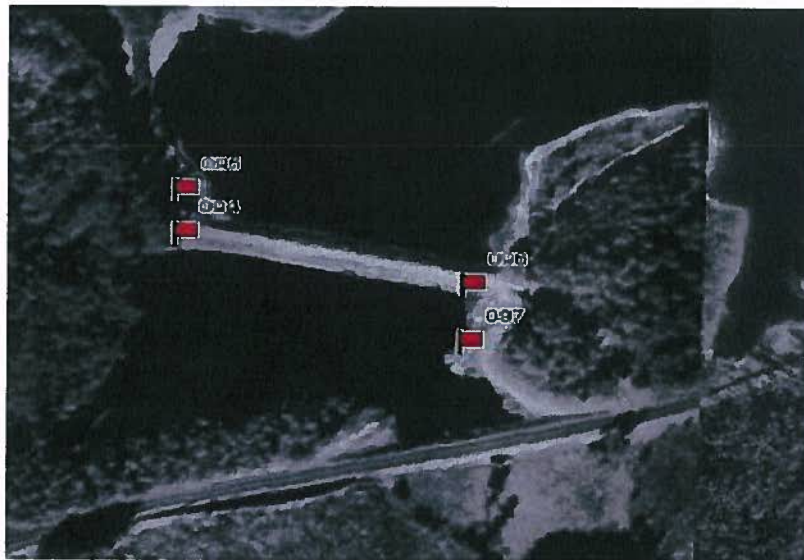
Ash Pond Emergency Overflow

094 The downstream outfall for the paved ditch has been undermined. Storm flows from the ditch undermine the ditch liner and will eventually remove the soil supporting the end of the ditch liner causing the liner to fail. **This area should be reinforced by placing Type I riprap in the pond at the outfall and choking that with Type III riprap. See sketch below.**

3-10-08 – Work completed

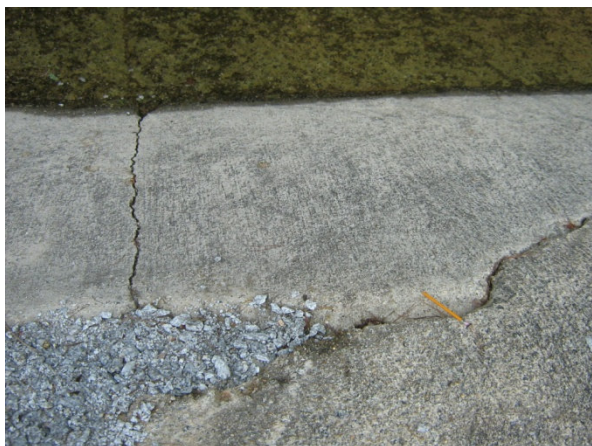
Photo 55: Potential undermining at overflow

The emergency overflow concrete channel was cracking and showed a potential to be undermined in future rain events. This is not a safety issue at this time, but needs to be monitored.

Continue current program. Begin monitoring erosion at concrete channel to avoid channel being undermined. Monitor cracking along the concrete channel.
